Waterproofing Systems

Horizontal barriers against rising damp in masonry

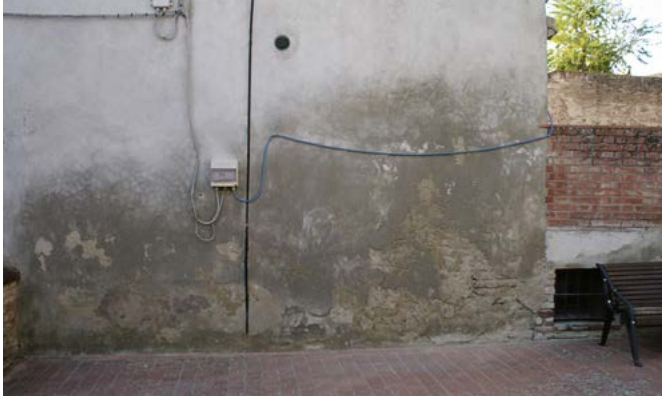
Change of color, reduction of the thermal insulation

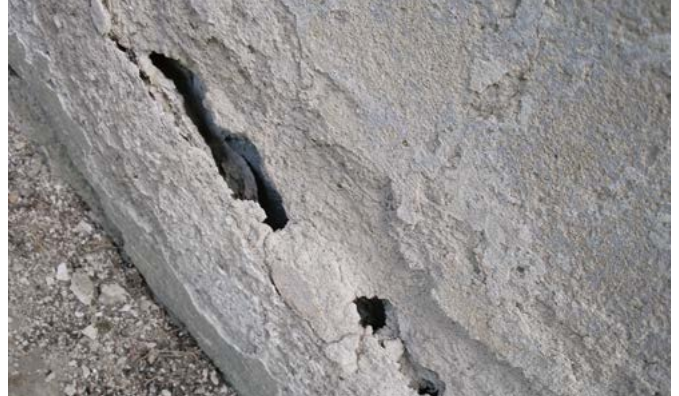
Damaged plaster

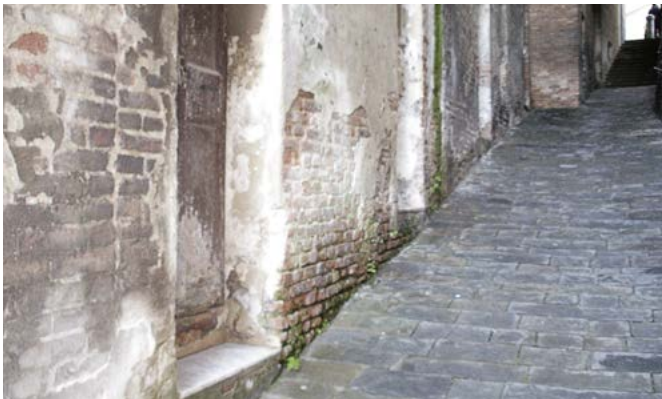
Destruction of render and mortar joints

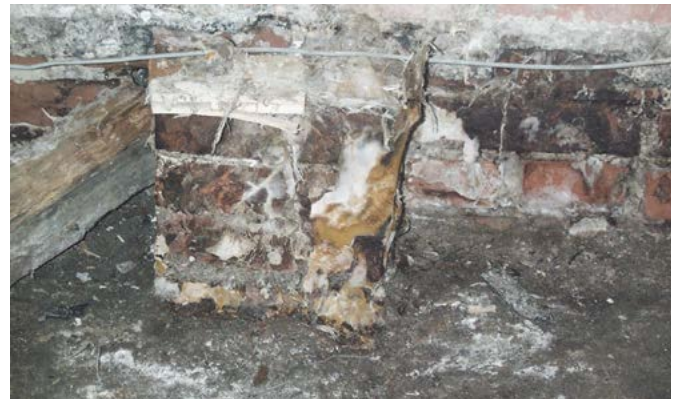
Development of mold and damage to the fabric of the structure

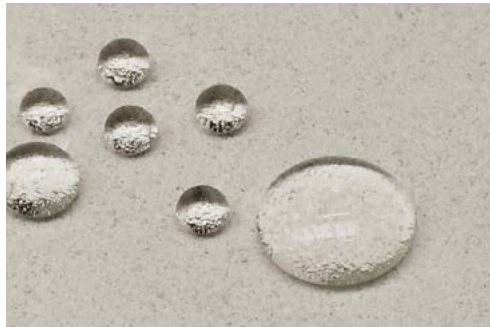
Hydrophobizing: Making the building material water repellent

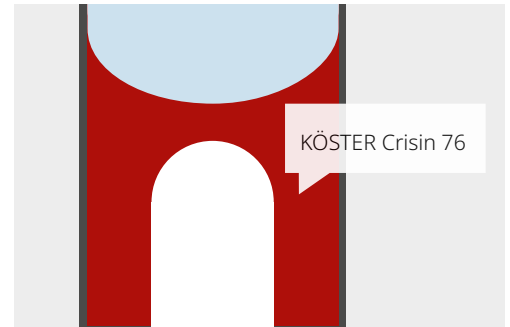
Narrowing/blocking the capillary, forming an elastic film in the capillary/reduce the pore diameter

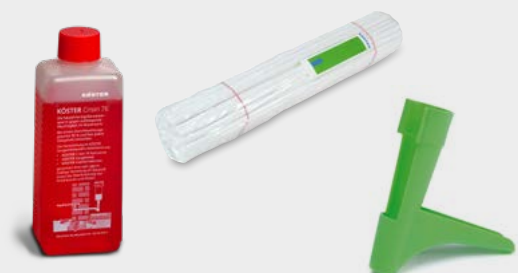
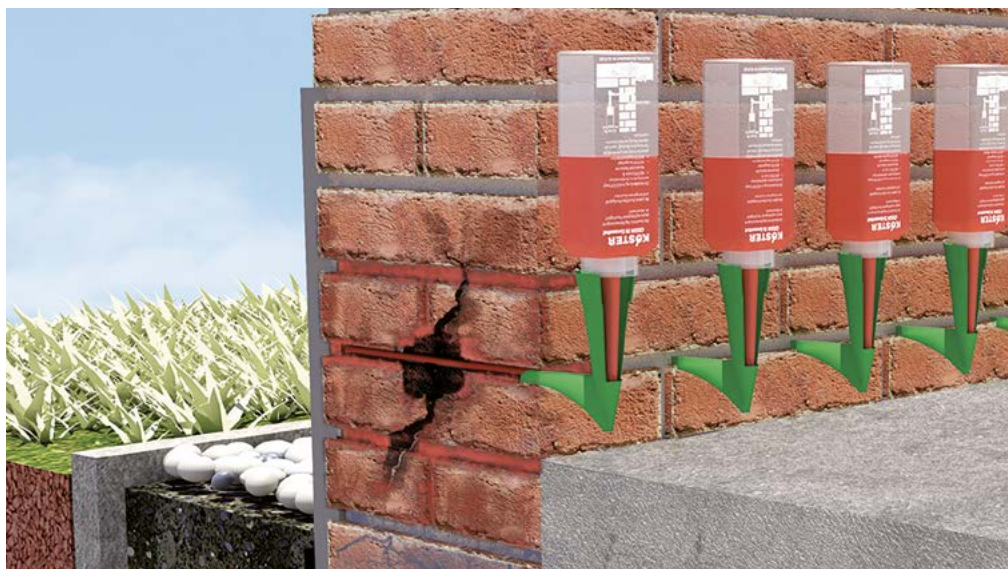
The system consists of the KÖSTER Crisin 76 cartridge, the KÖSTER Capillary Rod, and the KÖSTER Suction Angle.

Schematic representation.

The KÖSTER Capillary Rod acts like a wick, one end is inserted into the wall and the other end into the KÖSTER Suction Angle. From there, it draws the injection liquid into the wall. The KÖSTER Capillary Rod is available in lengths of 45 or 90 cm.

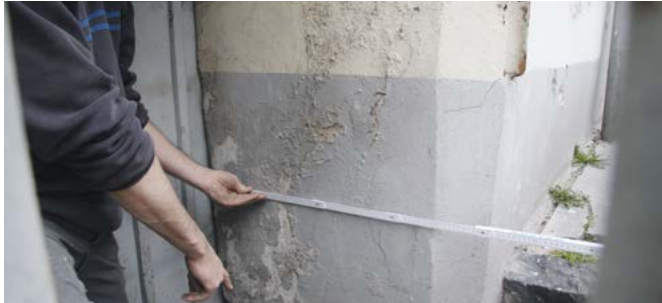
- 1 The salt and moisture contents are high in the masonry, the existing plaster is damaged.

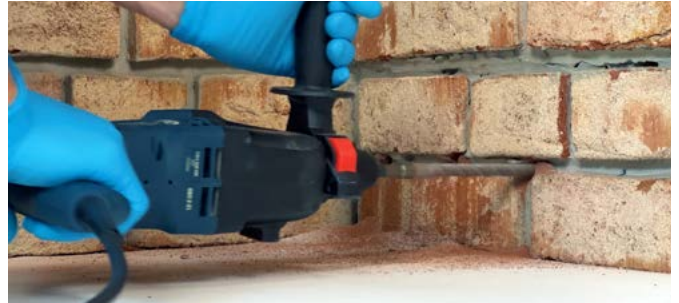
- 2 Boreholes are drilled into the inner wall with a distance of 10 cm from one another and depth of 40 cm (Wall thickness: 45 cm and 30 cm above grade).

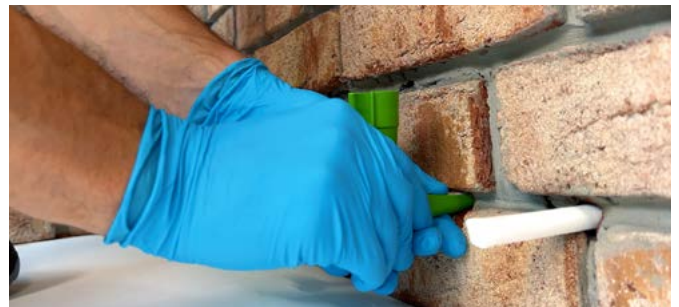
- 4 KÖSTER Capillary Rods are installed so that they protrude 7 cm from the borehole.

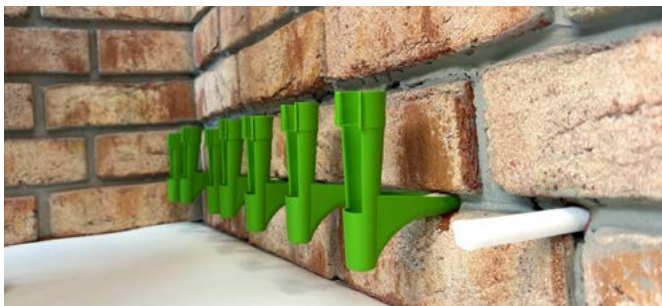
- 5 The KÖSTER Suction Angles are installed so that the KÖSTER Capillary Rods reach into the supply chamber of the KÖSTER Suction Angles.

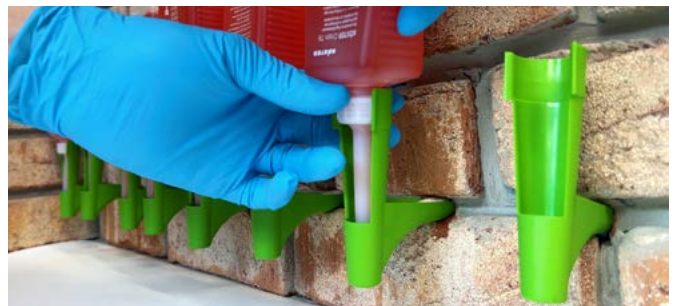
- 6 The KÖSTER Crisin 76 cartridges are then installed into the KÖSTER Suction Angle.

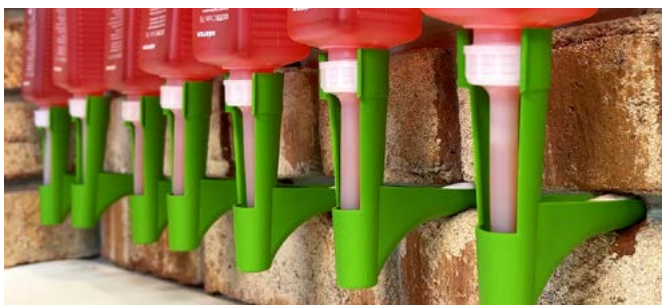
- 7 The nozzles of the cartridges sit directly on top of the capillary rod and allow the material to be soaked up.

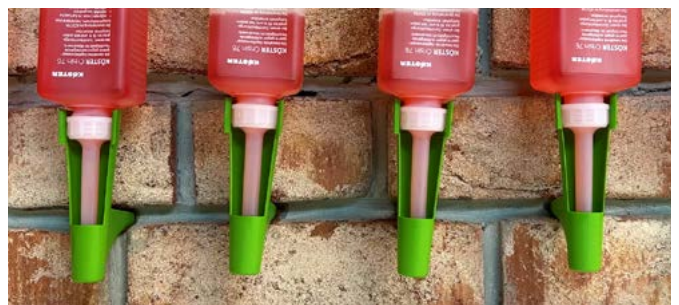
- 8 The pressureless injection of KÖSTER Crisin 76 into the masonry starts immediately after the installation of the cartridges.

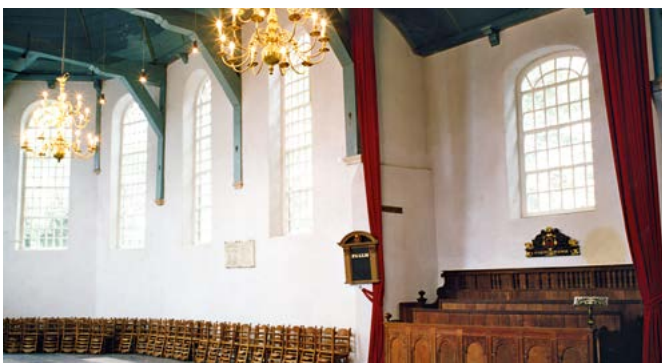
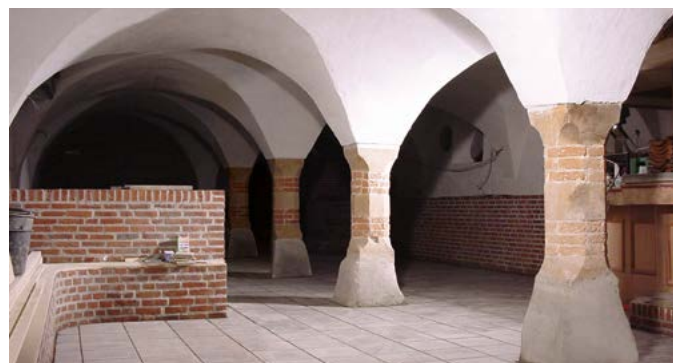
The interior walls of these buildings were restored with KÖSTER Restoration Plaster White.

KÖSTER Restoration Plasters are especially designed for the restoration of masonry with high salt and moisture contents. When rising damp is stopped with KÖSTER Crisin 76, KÖSTER restoration plasters help to dry out the while absorbing the remaining salts. KÖSTER restoration plasters withstand moist conditions since they do not contain lime or gypsum. They are open to water vapor diffusion and help to create a healthy and comfortable room climate.

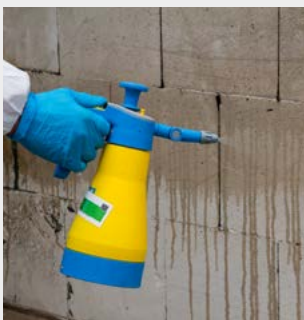
Remove old plaster. Spray KÖSTER Polysil TG 500 onto the surface to block salts and harden the substrate. Fill breakouts and holes with a KÖSTER Repair Mortar.

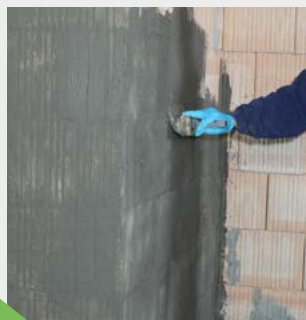
If negative side waterproofing is necessary, KÖSTER NB 1 Grey is applied in two layers.

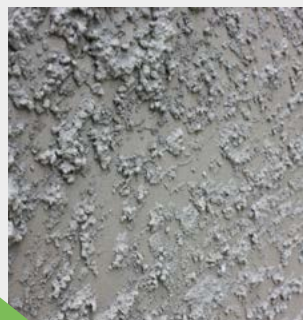
In the next step KÖSTER Restoration Plaster Key is applied to ensure the optimal adhesion of KÖSTER Restoration Plasters.

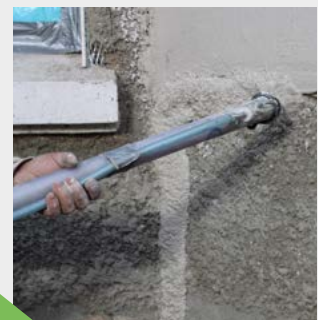
The KÖSTER Restoration Plaster is applied with a trowel or an appropriate mortar pump on the cured layer of KÖSTER Restoration Plaster Key. In the last step the surface is floated smooth.
